Stormport Professional Services Case Study

Low Voltage Link Box Change

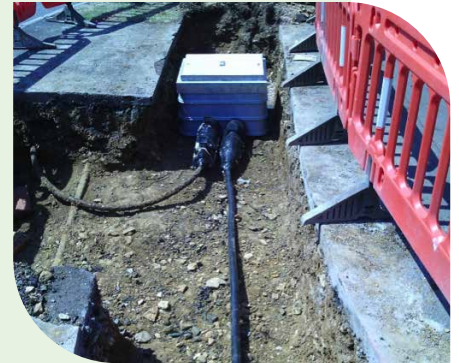
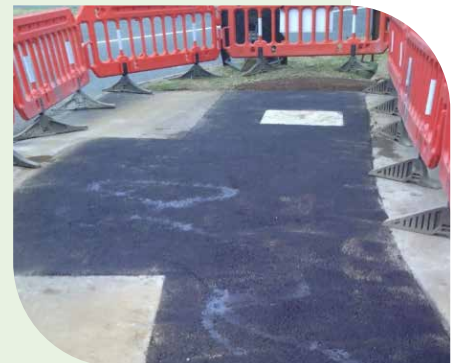
The redundant equipment is disconnected from the network and removed using our own vehicles. After which our civil staff carry out any excavation required to install the new link box.

After installation a jointing team joint it back onto the network after which it is commissioned and the network put back to its normal electrical configuration. The project manager carry's out quality checks at all stages of the project to ensure total compliance with the client's standards.
